Manhole Inspection Summary

Manhole # S15Y__011MH

Location Address: **1500 DESOTO RD**

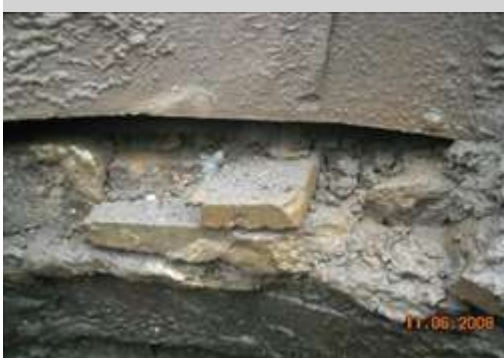
Defect 5

Condition: ☐ Sound ☐ Cracked ☐ Root Intrusion ☒ Loose Brick ☒ Deteriorated

Infiltration: ☐ None ☒ Joint ☐ Cracks ☐ Mortar ☐ Roots ☐ Wall

DETERIORATED CHIMNEY and infiltration from joint

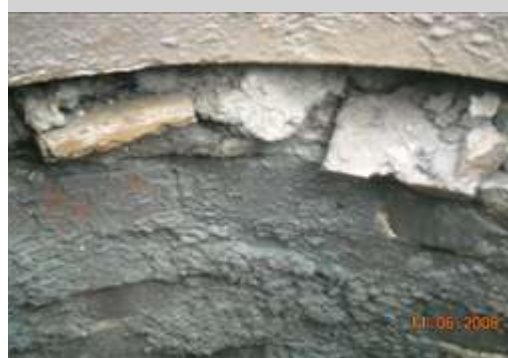
Defect 4

LOOSE CHIMNEY BRICKS

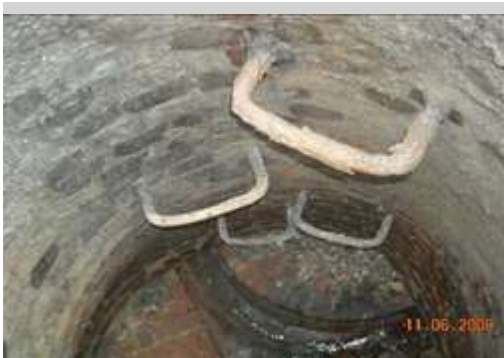
Defect 3

Count: **4** Missing: **0** ☒ Corroded

CORRODED STEPS

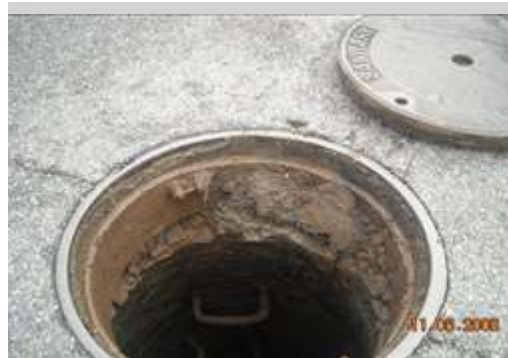
Defect 6

Subject To Ponding: **Sheeting**

INFLOW EVIDENCE FROM SHEETING

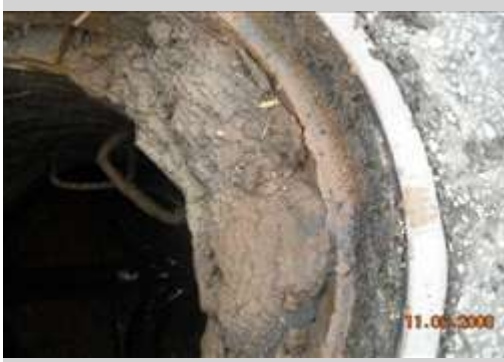
Defect 2

Offset: **5** (in.)

FRAME OFFSET

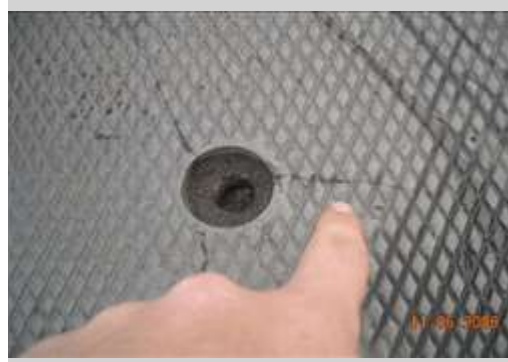
Defect 1

Comments **TRAFFIC CONTROL WAS REQUIRED TO COMPLETE INSPECTION. LOCKING LID WAS MISSING CENTER BOLT AND BAR.**

Condition: **Cracked**

CRACKED COVER

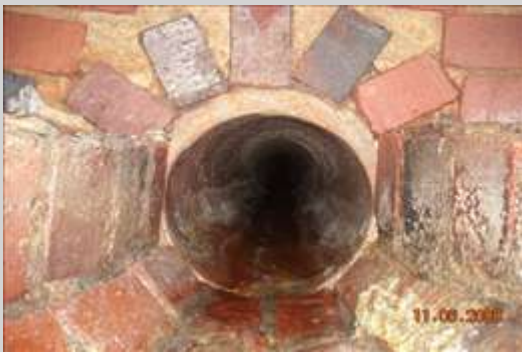
12 O'Clock Outflow

Pipe Height: **8.4** (in.) Rod and Bar (Angled)
Pipe Material: **Clay** ☐ Pipe Lined
Invert Depth: **9.15** (ft.) Flow Characteristics: **Slow**
Deposits: ☒ None ☐ Mud ☐ Sludge ☐ Debris ☐ Grease
Silt Depth: **0** (in.) Deposits Extent:
Infiltration: **None** Pipe Seal Cond: **Sound**

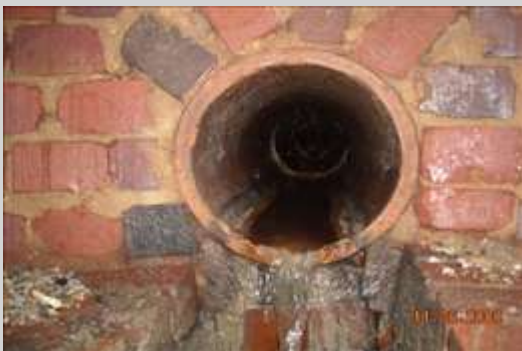
3 O'Clock Inflow

Pipe Height: **8.4** (in.) Rod and Bar (Angled)
Pipe Material: **Clay** ☐ Pipe Lined
Invert Depth: **8.33** (ft.) Flow Characteristics: **Slow**
Deposits: ☒ None ☐ Mud ☐ Sludge ☐ Debris ☐ Grease
Silt Depth: **0** (in.) Deposits Extent:
Infiltration: **None** Pipe Seal Cond: **Sound**

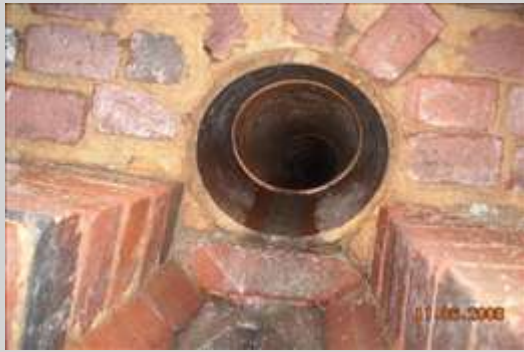
6 O'Clock Inflow

Pipe Height: **8.4** (in.) Rod and Bar (Angled)
Pipe Material: **Clay** ☐ Pipe Lined
Invert Depth: **8.77** (ft.) Flow Characteristics: **Slow**
Deposits: ☒ None ☐ Mud ☐ Sludge ☐ Debris ☐ Grease
Silt Depth: **0** (in.) Deposits Extent:
Infiltration: **None** Pipe Seal Cond: **Sound**

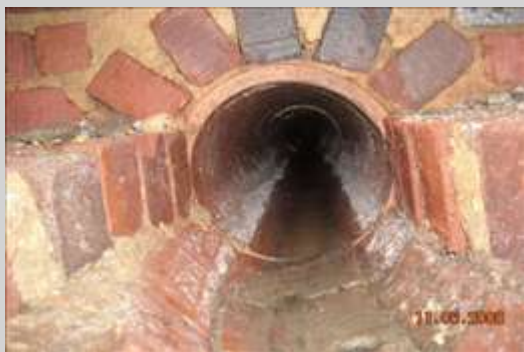
9 O'Clock Inflow

Pipe Height: **8.4** (in.) Rod and Bar (Angled)
Pipe Material: **Clay** ☐ Pipe Lined
Invert Depth: **9.06** (ft.) Flow Characteristics: **Slow**
Deposits: ☒ None ☐ Mud ☐ Sludge ☐ Debris ☐ Grease
Silt Depth: **0** (in.) Deposits Extent:
Infiltration: **None** Pipe Seal Cond: **Sound**
